Measures to mitigate direct flood risks at riverbank filtration sites with a focus on India

Cornelius Sandhu^{1*}, Thomas Grischek¹, Fabian Musche¹, Wolfgang Macheleidt¹, Andreas Heisler², Jan Handschak³, Pooran S. Patwal⁴ and Prakash C. Kimothi^{4,5}

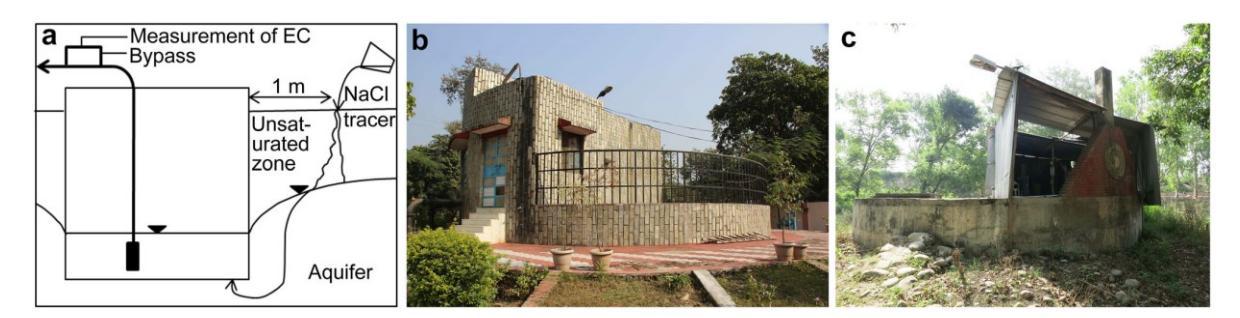
Fig. 2a. Principle of using a tracer to illustrate the pathway of contamination into a caisson well (e.g. Haridwar) due to seepage of flood water (Sandhu et al. 2016). **b** Caisson well in Haridwar in good sanitary condition, whose base is protected by concrete seal / apron. **c** Well with cracks / fissures in the caisson and the absence of a concrete seal.

For wells with a concrete seal (e.g. Fig. 2b), the arrival of the tracer was not recorded within the 24 h observation period. Thus it may be concluded that for a caisson well, without a concrete seal and in poor sanitary condition, water that accumulates on the ground surface within 1 m of the caisson as runoff from an intense rainfall event, floods or bathing and washing, can come into contact with the groundwater and eventually flow into the well within 5 h. Furthermore, the seepage of flood or wastewater from anthropogenic activities at the well along preferential flow paths (such as the outer wall of the caisson) and shallow depth to the groundwater table, can result in even shorter travel times of 20–45 min to enter the well.

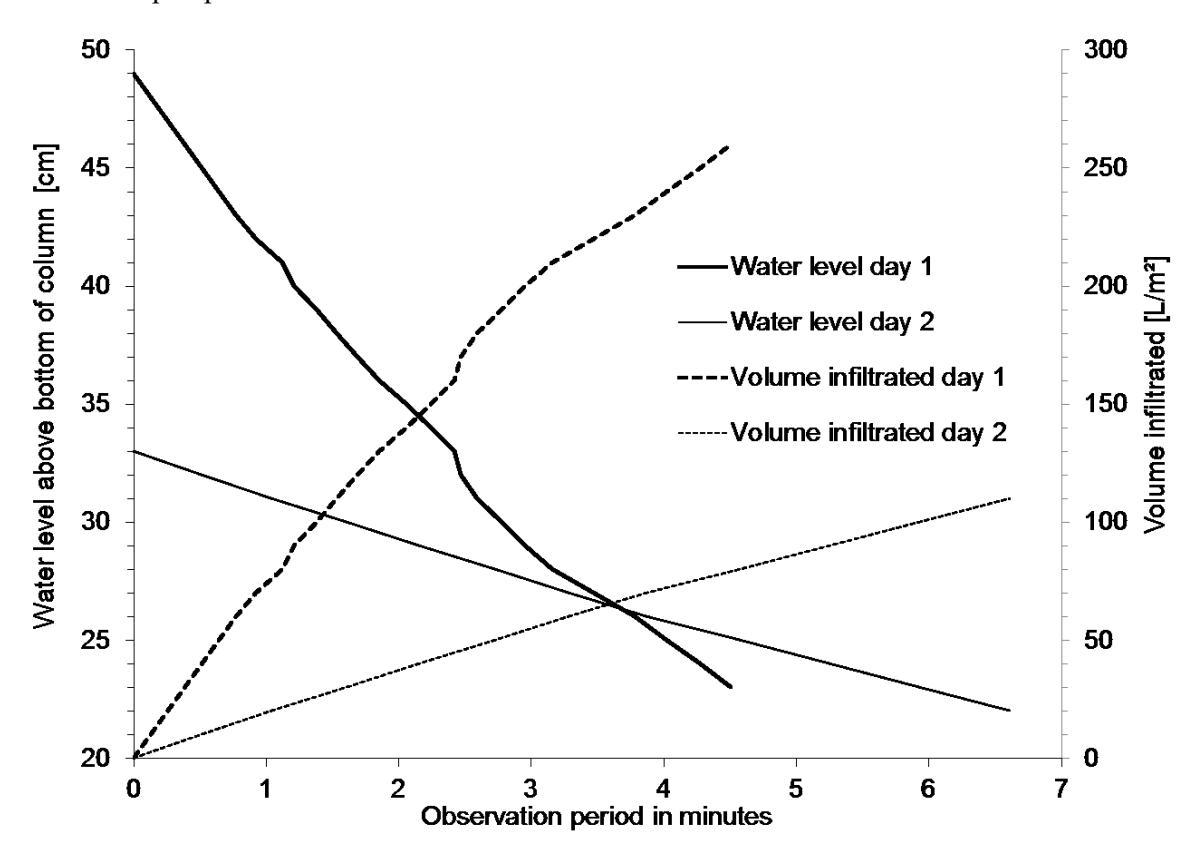
Fig. 6. Infiltration of water around the perimeter of a RBF vertical well casing in India (Handschak and Musche, TU Dresden and HTW Dresden, unpublished data)

The infiltration of the NaCl tracer ("Trial to determine watertightness of annular sealing of vertical wells at a RBF site in India") to determine short-circuiting through the annular space between the well casing and borehole wall appear to be inconclusive if the EC of the abstracted well water is considered because no significant increase in the EC was recorded. Data from water level loggers installed in the production well showed that during the 72 h period, the well was nearly continuously in operation except for 1 h per day when the well was shut down as part of its routine operational schedule. However, due to the relatively high hydraulic conductivity (3×10^{-4} m/s; determined by a pumping test in 2015), low drawdown (1 m) and corresponding low gradient, the tracer could have drifted past the well and not been captured by it. Or the tracer may not have reached the groundwater table during this period. These conclusions are substantiated by the fact that the water level in the well was not too shallow (13.6 m below ground level during operation) and the well is quite deep (50 m). The exact filter-screen length and depth were not available. Nevertheless, it can be concluded that there is no immediate risk from surface water contamination, at least during an intensive rainfall even or sporadic washing / bathing activities immediately next to the well.

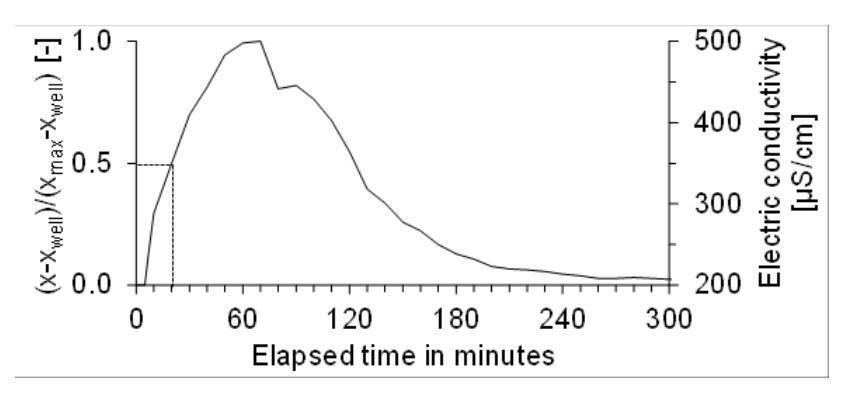
Before the NaCl tracer test on a caisson well without a concrete seal in Haridwar, the pumped water had an ambient EC of 201 μ S/cm. As a result of the infiltration of a total volume of ~0.48 m³ of tracer solution (125 g/L NaCl) at the well, having an EC of ~180 mS/cm, the EC of the pumped water increased to a maximum of 488 μ S/cm. 50 % of the peak EC value was observed within a very short time of 20 min (Fig. 7). The relatively quick breakthrough of the tracer emphasizes the high risk of contamination not only from direct flood water entry, but also from seepage of grey water from anthropogenic domestic activities taking place near the well (e.g. bathing, washing and defecation).

Fig. 7. Breakthrough of 50 % of tracer into a RBF well was measured after 20 min (t_{50}) (x = EC of pumped water from well; x_{max} = maximum EC of pumped water; x_{well} = ambient EC of well water)

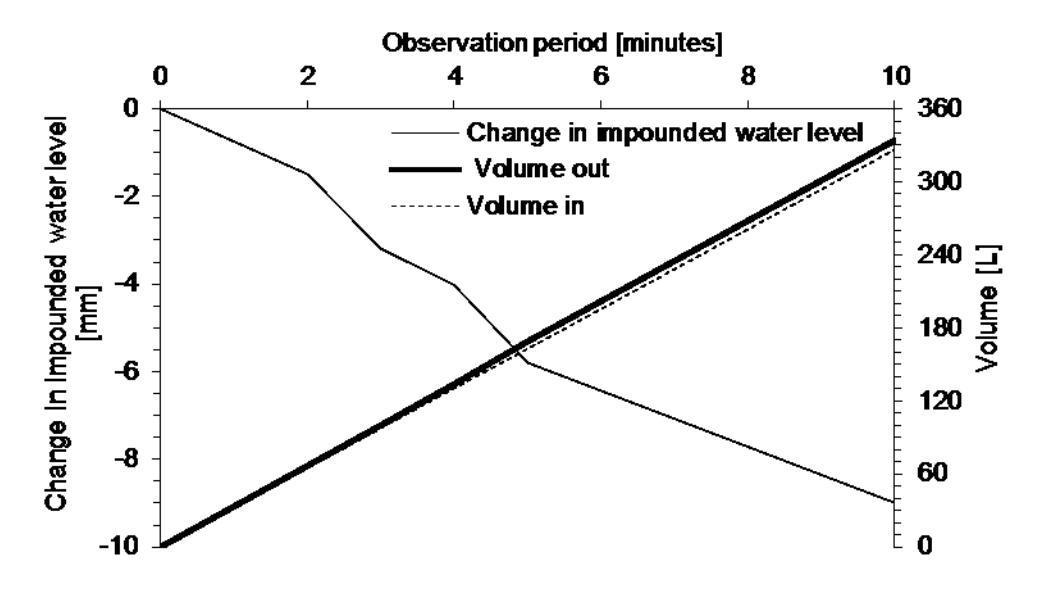
The impounding experiment began with the commencement of pumping of water into the cylinder. Initially the water level rose to a point just above the well head cover. But thereafter it was observed that despite a constant inflow of 32.6 L/min, the water level steadily decreased and could not be maintained constant. Accordingly for an observed decrease in the impounded water level of 9 mm after a 10 min period and with a total volume of 326 L pumped into the cylinder during this period, a total outflow of 334 L was calculated (Fig. 8). The additional 8.2 L of water that flowed out were contributed from the initial storage in the cylinder. During the experiment no outflow of water was noticed from the clay seal around the cylinder. Thus the heavy mass of the cylinder coupled with the swelling clay had apparently created an effective seal between the cylinder and well head. Hence it can be concluded that 334 L of water seeped into the well chamber during a 10 min observation period.

Fig. 8. Seepage of water into well chamber during impounding experiment

After conclusion of the experiment and removal of the apparatus, the well cover was opened and inspected for non-watertight points through which the impounded water seeped into the chamber. The rubber ring that is intended to provide a seal between the well cover and the rim or frame of the cover had a visible gap and did not fully encompass the rim. Furthermore gaps were visible between the rim and the well head and in the area where the ladder is mounted to the chamber. Subsequently, with the intention to conduct a pressurization experiment to observe if smoke generated from cartridges placed inside the closed well chamber escapes, it was observed that smoke escaped even without the need to pressurize the chamber.

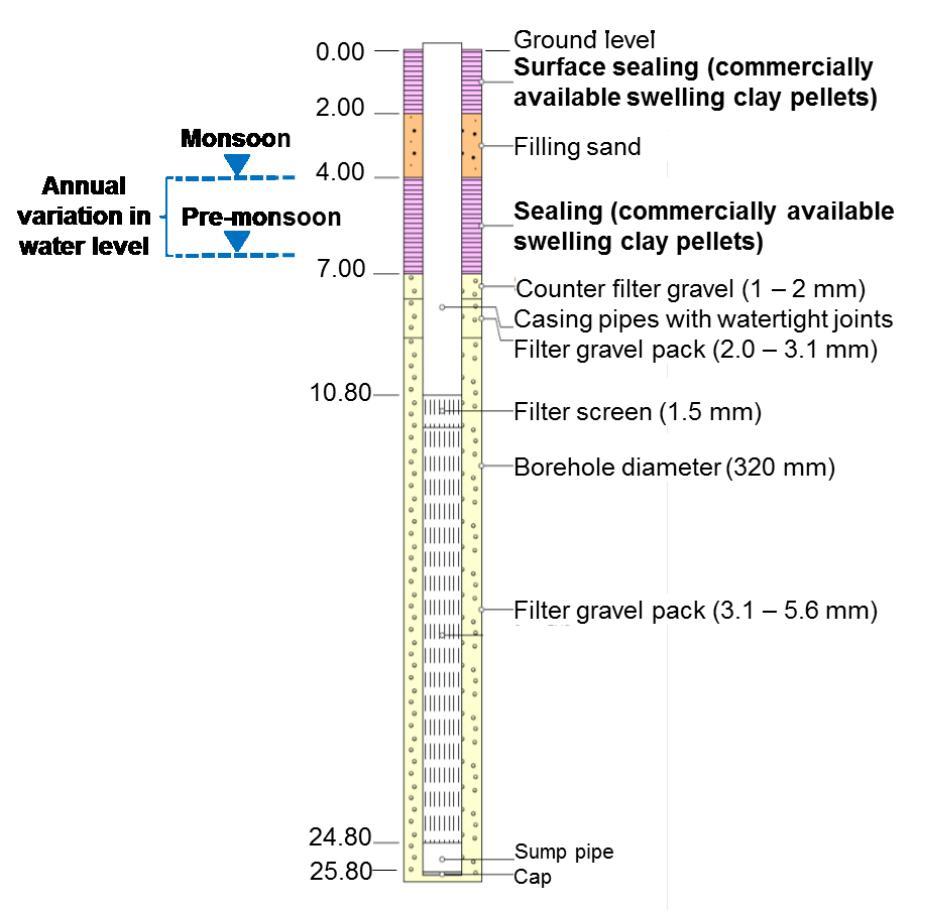
Fig. 9. Proposed sealing of RBF well with sealing of annulus (depth in metres below ground level)

For the improved sealing, the annulus should ideally be sealed using commercially available swelling clay pellets at critical points such as at the ground surface and at the depth of the groundwater table (Fig. 9). The available bentonite in India attains stability of form and against erosion and can be used for sealing. The sealing at the groundwater table should, as far as possible, remain moist year-round. It is necessary to take the lowest pre-monsoon (deepest) groundwater table into consideration so that the lower most clay pellets are in continuous contact with the groundwater table and thus the continuous swelling is sustained. If this is not the case, then drying of the pellets will result in shrinkage leading to the formation of cracks in the clay and the creation of a gap between the clay seal and the casing pipe of the well and eventually also with the borehole wall. This gap will result in preferential flow path for water to short circuit. In case a greater depth has to be sealed that would require large quantities of clay pellets (cost factor), then the total depth over which the clay seal is to be installed may be broken into an upper and lower sealing segment with a sand segment in between (Fig. 9). The installation of a finer counter filter gravel pack (1-2 mm) between the overlying sealing of annulus and the underlying main filter gravel packs (2-3.1 mm and 3.1-5.6 mm) will prevent the clay from subsiding into the pores of the coarser filter grains, especially since the main gravel pack is expected to subside during well operation.

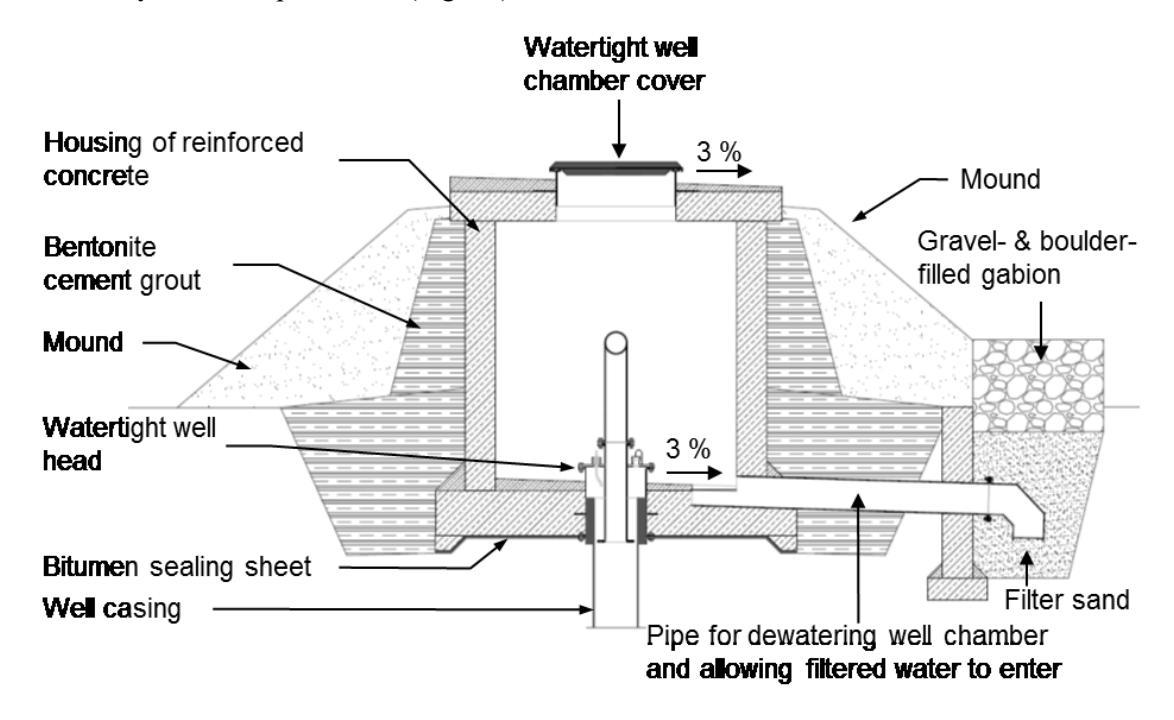
Fig. 10. Conceptual design for a well chamber with a watertight cover and well head

Safeguarding RBF wells during floods by preventing the direct entry of flood water (short circuiting) and ensuring continuous operation remain critical issues for sustainable drinking water production not only in India but most countries affected by floods during monsoon in South and South-East Asia. While practical measures have been taken by public water supply companies in Germany (e.g. in Görlitz by the Neisse River, in Leipzig by the Mulde River and in Dresden by the Elbe River) and the Netherlands to flood-proof well chambers using watertight elements and other technical measures (Rambags et al. 2011), designs for flood-proof well chambers for RBF sites in India exist only at a conceptual level (Fig. 10).
