Measures to mitigate direct flood risks at riverbank filtration sites with a focus on India

Cornelius Sandhu^{1*}, Thomas Grischek¹, Fabian Musche¹, Wolfgang Macheleidt¹, Andreas Heisler², Jan Handschak³, Pooran S. Patwal⁴ and Prakash C. Kimothi^{4,5}

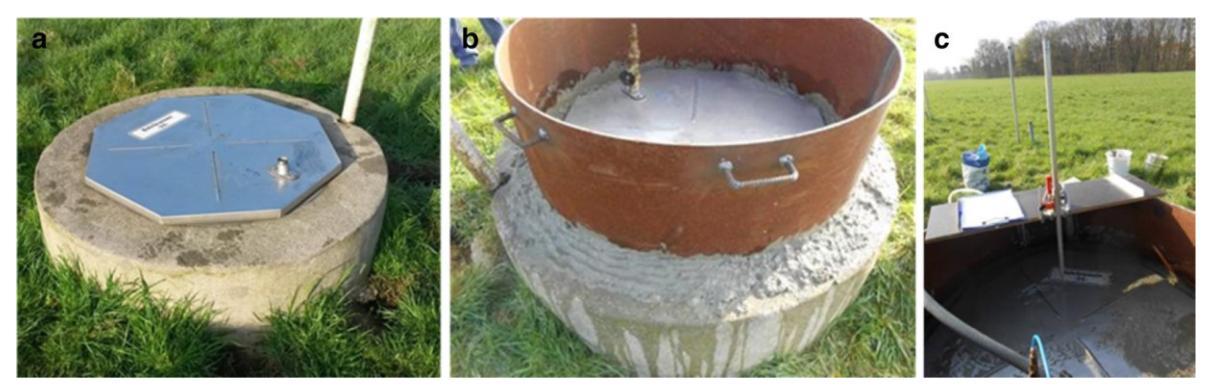
Fig. 4a. RBF well used for field trial in Germany. b Cylinder placed atop well chamber and sealed with swelling clay at interface. c Water level measurement.

The impounding experiment began with the commencement of pumping of water into the cylinder. Initially the water level rose to a point just above the well head cover. But thereafter it was observed that despite a constant inflow of 32.6 L/min, the water level steadily decreased and could not be maintained constant. Accordingly for an observed decrease in the impounded water level of 9 mm after a 10 min period and with a total volume of 326 L pumped into the cylinder during this period, a total outflow of 334 L was calculated (Fig. 8). The additional 8.2 L of water that flowed out were contributed from the initial storage in the cylinder. During the experiment no outflow of water was noticed from the clay seal around the cylinder. Thus the heavy mass of the cylinder coupled with the swelling clay had apparently created an effective seal between the cylinder and well head. Hence it can be concluded that 334 L of water seeped into the well chamber during a 10 min observation period.

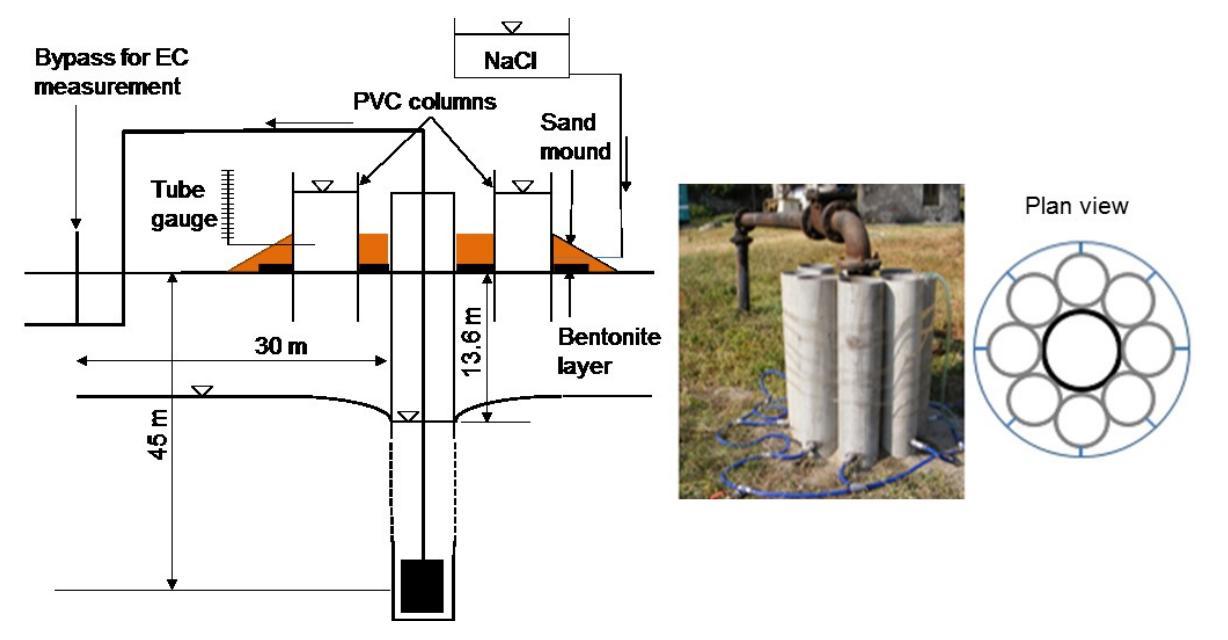
Fig. 5. Set-up for tracer infiltration and determination of seepage flux at a RBF well in India (Handschak & Musche, TU Dresden & HTW Dresden, unpublished figure)

Due to the high infiltration rate and originally unsaturated soil at ground level it was not possible to create an impoundment during the first test. Therefore rubber sheets were placed at the bottom of each column (pipe) to enable the water level to rise. Once impounded, the rubber sheets were suddenly removed and the reading of the water level commenced. However, due to the higher head in the columns, the water seeped upwards through the soil around the columns and spread to the surrounding ground. A sand embankment to increase the weight was insufficient to prevent erosion of the soil. A subsequently placed bentonite layer, weighed down by a mound of sand, was applied around the columns. With this setting no undesired outlet of the tracer solution to the ground was observed. Overall three NaCl tracer infiltrations, each of 200 L, were conducted (Fig. 6), whereby the infiltration rate decreased from 58 L/min/m² on day 1 to 17 L/min/m² on day 2. The EC of the abstracted water was measured on a bypass of the supply pipe at regular intervals over a 72 h period. Additionally the water level and the temperature in the well were recorded to deduce the operating hours of the pump.
